**Annual Report to Alaska Department of Environmental Conservation**

# Commitment to Corrosion Monitoring Year 2001

Corrosion, Inspection and Chemicals (CIC) Group BP Exploration (Alaska) Inc.

March 2002

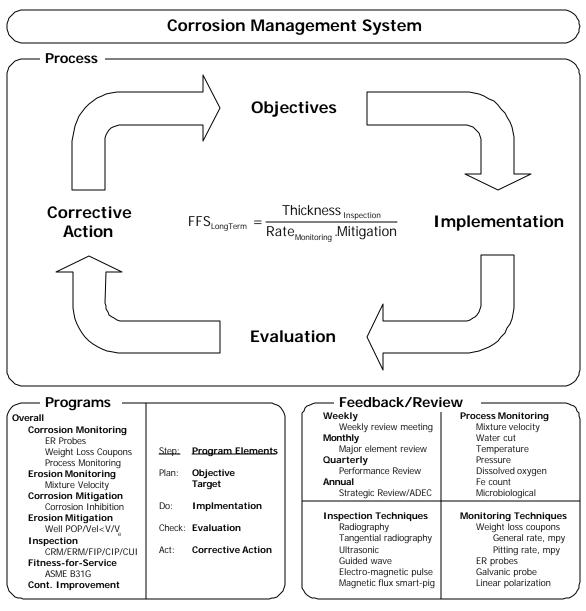
Figure B.1 Overview of the Corrosion Management Process

The Corrosion Management System consists of a number of major program elements, which follow a simple management process. The overall system is shown in Figure B.1.

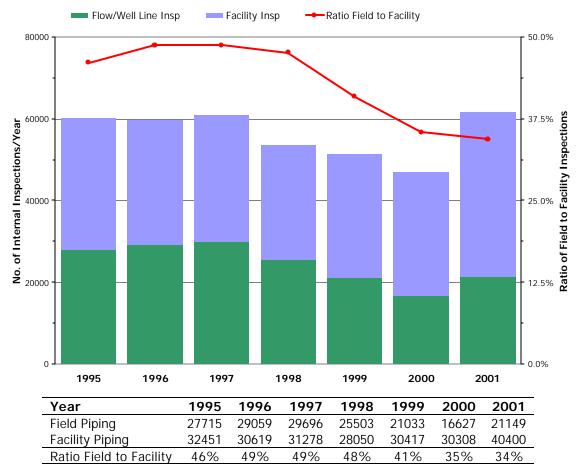
Figure B.4 Breakdown of Inspection Activity Between Field and Facility Piping

The relative effort of the program has changed over this timeframe from approximately 50/50 distribution between the facilities and the field, to the distribution seen today of approximately  $^{1}/_{3}^{rd}$  field and  $^{2}/_{3}^{rd}$  facilities – see Figure B.4. This represents a change in emphasis of the inspection toward the facilities program as the majority of the field corrosion control issues have been or are being addressed and are managed through the corrosion monitoring program which provides more timely feedback on the performance of the corrosion mitigation effort than is possible with inspection.

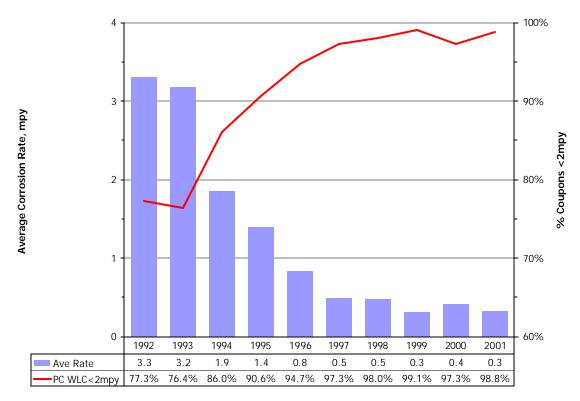
Figure C.1 Flow Line Corrosion Rate Trend 1992 to 2001

in the cross-country flow line corrosion rates. This same result is also seen in the inspection history as discussed in a later section. The decrease in corrosion rate in the 3-phase systems is attributable to the implementation of an aggressive corrosion inhibition program. A similar trend in performance improvement is seen in the well lines, however, the ultimate performance is not as good as the flow lines but still considerably below the 2 mpy targeted rate.

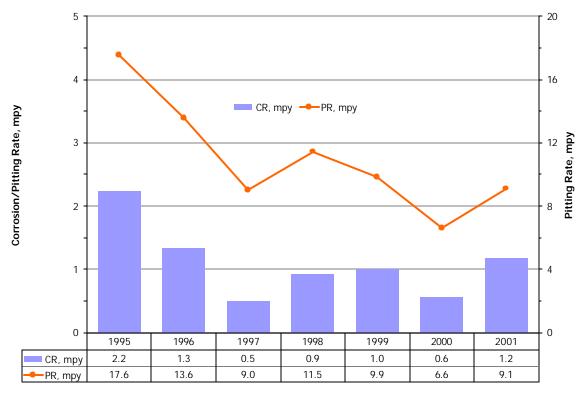
Figure C.4 Pitting Rate and Corrosion Rates for the PW System

Figure C.4 is a summary of the corrosion and pitting rate data for the produced water system. As the water in the produced water injection system essentially comes from a single source, i.e. the separation plant, the results from the corrosion-monitoring program are analyzed in aggregate. The data shows that the general corrosion rates in the produced water system have fallen as the level of inhibition in the 3-phase system upstream of separation has increased. However, the corrosion activity in the produced water system, both pitting and general corrosion rate have risen in 2001.

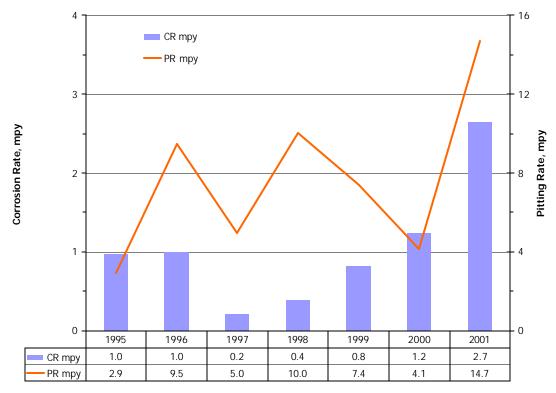
Figure C.5 Pitting Rate and Corrosion Rates for the SW System

In addition, the corrosion-monitoring program in the main seawater supply line has been changed to increase the pull frequency of the weight loss coupons from annual to quarterly effective end 2001.

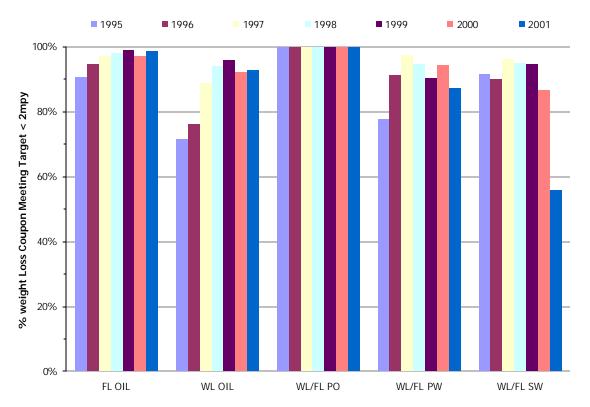
Figure C.8 Summary Equipment and Service Corrosion Coupons Meeting Target

**Flow Line Oil Service** - For the cross-country flow lines in 3-phase production service, 99% of these lines met or beat the corrosion control target of 2 mpy in 2001. This continues a trend from 1995 of improving corrosion control in this system with the average corrosion rate falling from 1.4 mpy in 1995 to 0.3 mpy in 2001.

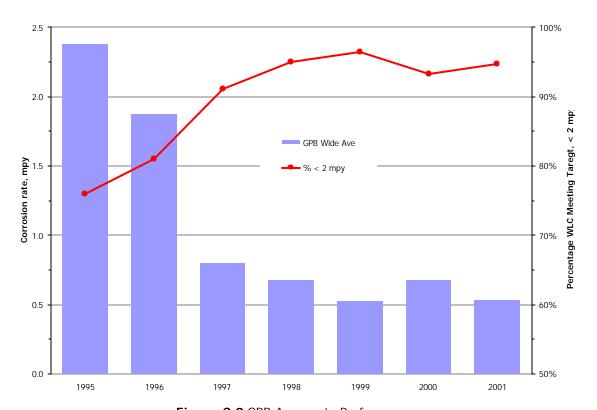
Figure C.9 GPB Aggregate Performance

It should be noted that the majority of the pipelines are in 3-phase (OIL) service and hence the majority of the corrosion monitoring is also in 3-phase service. As a consequence, the aggregate data shown above is dominated by the performance of the 3-phase system.

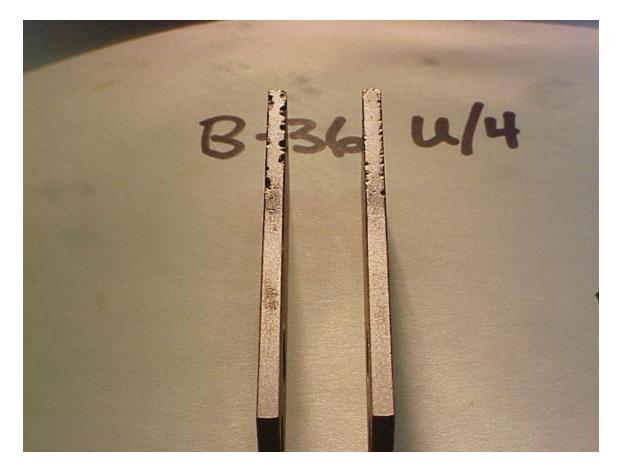
Figure D.4 Corrosion coupons pulled after an 'unsuccessful' chemical trial

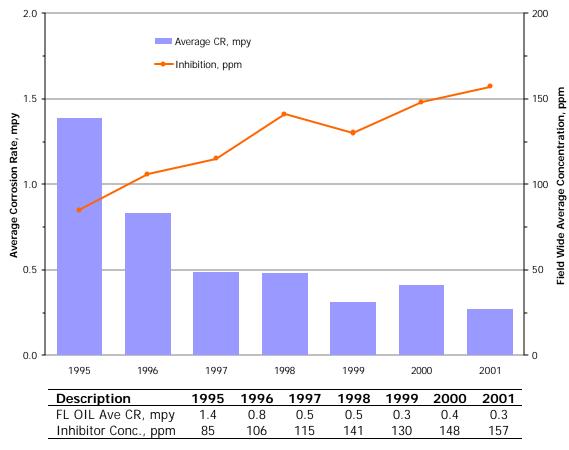
Figure D.8 Average Concentration versus Corrosion Rate

Figure D.8 shows the correlation between the increased level of corrosion inhibitor and the reduction in average corrosion rate from 1995. As might be expected, the decline in average corrosion rate correlates with the increase in corrosion inhibition levels over time. The inhibition levels have increased approximately 80% from 1995 to 2001, with a field-wide average concentration of 85 ppm to 157 ppm, respectively. As a result the corrosion rates have fallen by ~80% from 1.4 mpy in 1995 to 0.3 mpy in 2001.

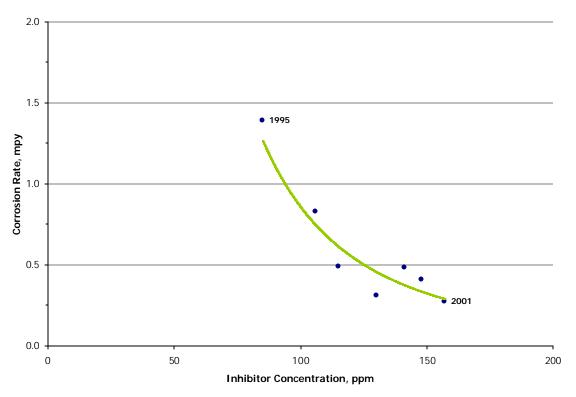
Figure D.9 Corrosion Inhibitor Concentration vs. Corrosion Rate

Figure D.9 shows the annual field-wide average corrosion inhibitor concentrations and annual average corrosion rates for 3-phase production flow lines plotted against each other. The figure shows how the additional corrosion inhibitor has reduced the corrosion rate through time, but also shows an inherent limitation of corrosion inhibition as the minimum corrosion rate (or maximum corrosion inhibitor efficiency) is approaching an asymptote of ~0.25 mpy.

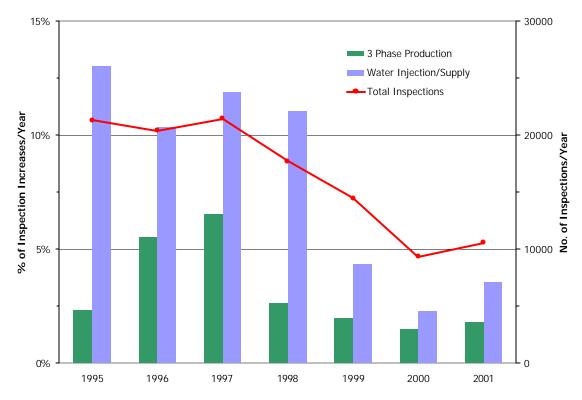
Figure E.7 Flow Line Internal Inspection Increase by Service

For the water system, corrosion activity is seen to be declining over the last 5 years; however, the increase in activity seen in the flow lines has not yet translated to activity in the well line data.

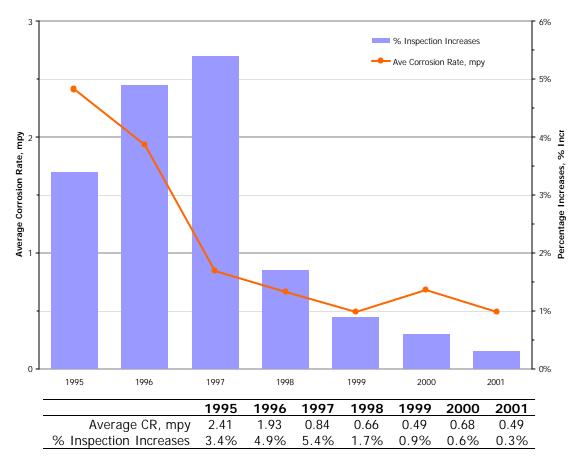
Figure E.9 Correlation of Corrosion Rate and %Increases

- As the corrosion rates decrease as a result of the effectiveness of the inhibition program, then further program optimization will be driven by the information gained from the corrosion monitoring program rather than the inspection program
- Timely optimization of the chemical program can not be reliant on feedback from the inspection data but must be managed through the corrosion monitoring program
- Because of the lower sensitivity of the techniques used in the inspection program, the corrosion rates in the 3-phase flow lines are below the detection limits for inspection; therefore corrosion rate monitoring becomes a function of the coupon program leaving inspection as a confirmation and integrity assessment tool

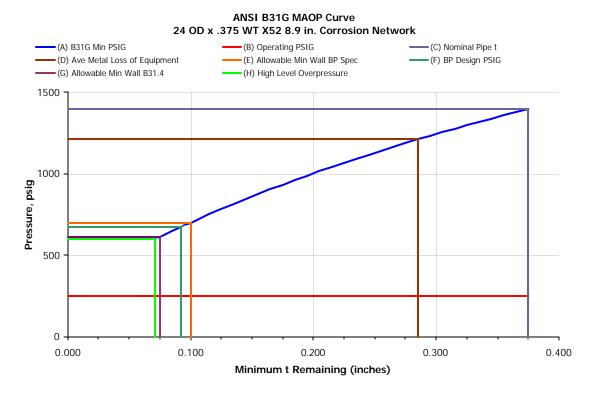
Figure E.10 MAOP versus Remaining Wall Thickness

Figure E.10 summarizes the dependence of Maximum Allowable Operating Pressure (MAOP) with the remaining wall thickness of a section of flowline based on ANSI/ASME B31G. The example and discussion below is for a typical cross-country 24" diameter low-pressure (LP) flowline. The same ANSI/ASME B31G criteria are applied to remaining flow and well lines with the appropriate characteristics and parameters substituted from the example below.

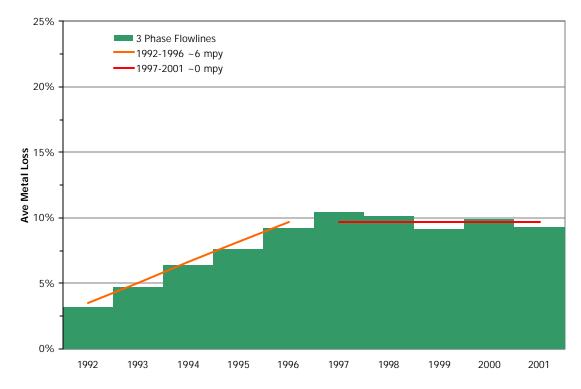
Figure E.12 GPB Average Flow Line Condition Since 1992

early part of the 1990's and has been considerably reduced since the introduction of an aggressive corrosion inhibition program.

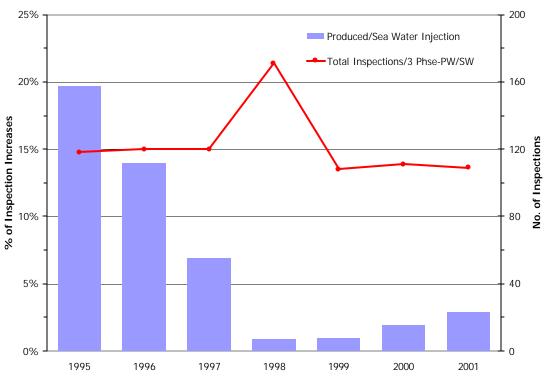
Note: There were no inspection increases in the production line as it is comprised of duplex stainless steel
